A CRANE INCIDENT – JAMMED LOAD THE DARK SIDE OF DUAL CONTROLS

Crane Incident - Jammed Load

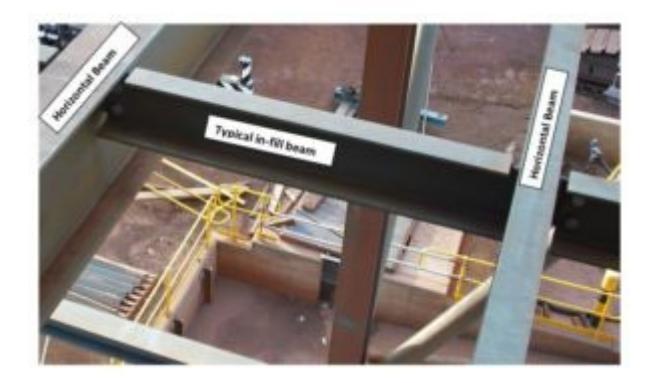
The task was to lift, position and attach minor structural steel beams into the main structure of a screen-house using a modern hydraulic telescoping boom type crane.

The crane was controlled through hand operated levers for swing, boom hoist, main winch and boom telescoping and 2 foot control pedals for boom hoist and boom telescoping.
